MARLBROOK QUARRY RESERVOIR

**REPORT ON AN INSPECTION UNDER SECTION 8 OF THE
RESERVOIRS ACT 1975**

October 2019

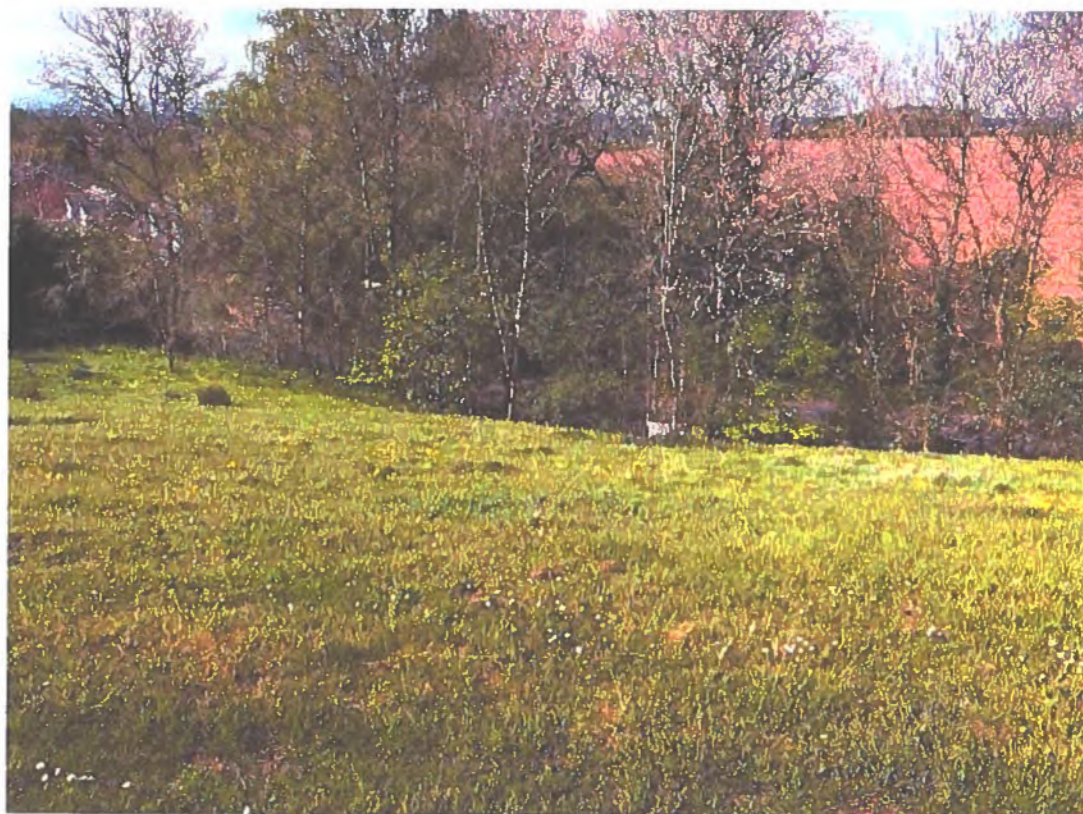
Downstream face

The downstream face appeared to have a satisfactory line and level although clearly the restoration of the lower part of the slope is much better than in the upper part of the slope. However, even the upper part of the slope the situation appears satisfactory with good grass cover and no signs of instability. In my opinion, if attempts were made to 'improve' the site then one would have to remove material that had been in place for more than ten years without problem – and this would be a retrograde step.

I recommend the grass to all surfaces of the embankment is cut frequently and at least once a year to ensure the grass is cut short and coarse vegetation is cut off, to encourage a good sward, [REDACTED]

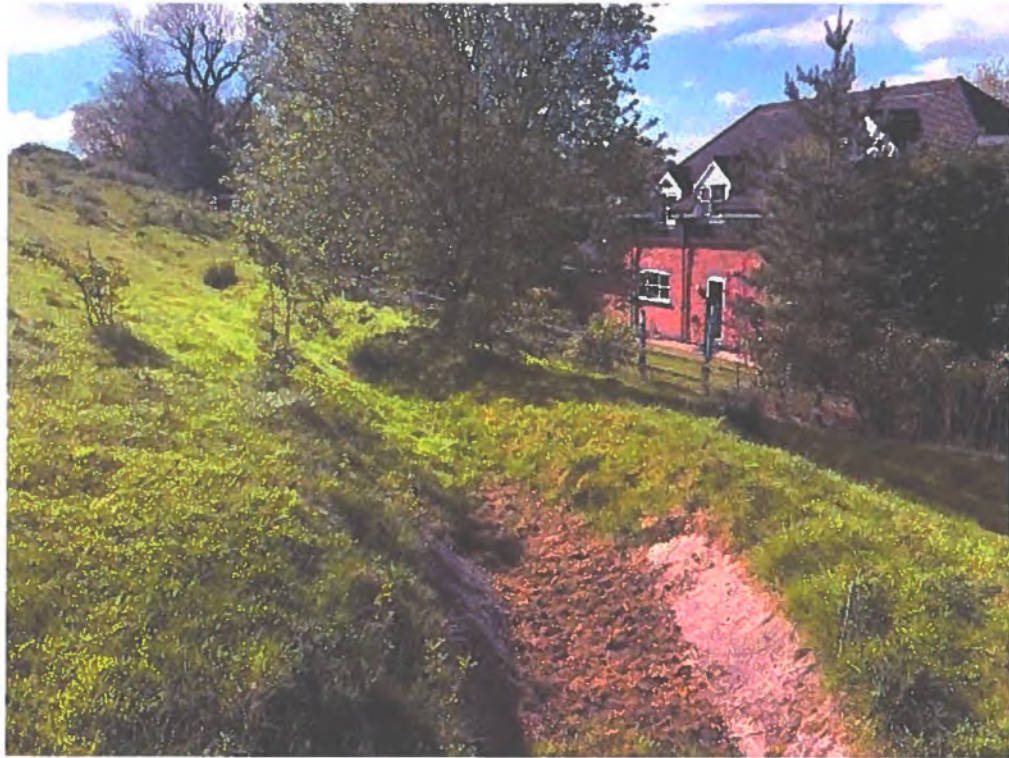
Property downstream

Immediately downstream of the dam are a number of residential properties associated with Lower Marlbrook and Upper Catshill in the natural valley of the stream before it passes under the M42.

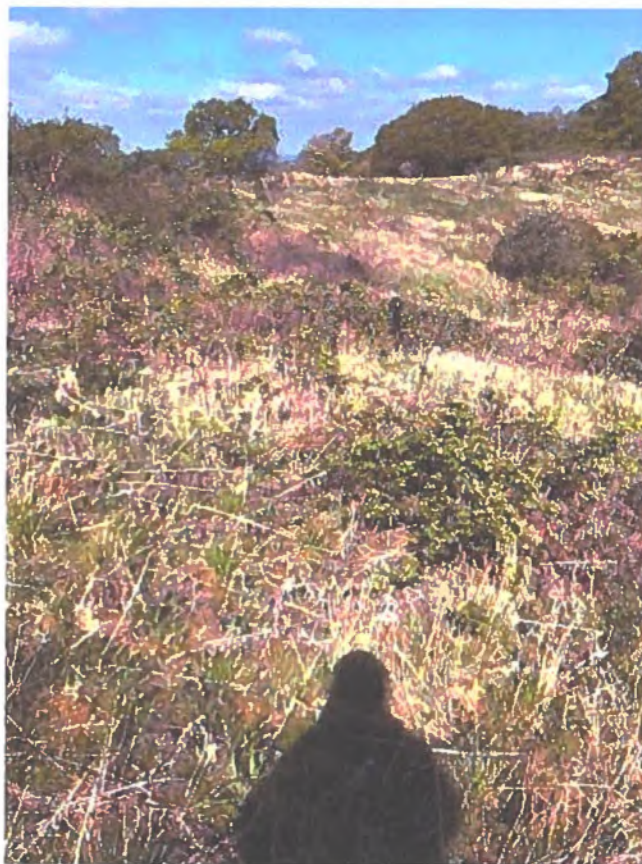
Basin/crest at right side

The crest is a little uneven in places but has a satisfactory line and level and good grass cover. [REDACTED]
