Name of Reservoir: *Marlbrook Quarry Reservoir*

Report under Section 8

Robert J Mann, BA, MICE, MCIWEM, AR Panel Engineer

Date: January 2015

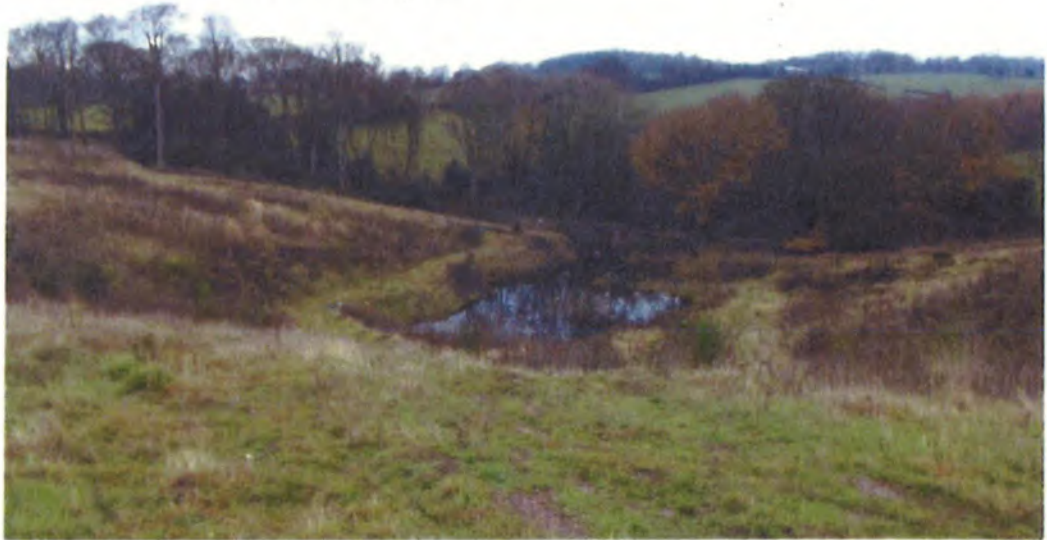
Reservoir pool area – looking north

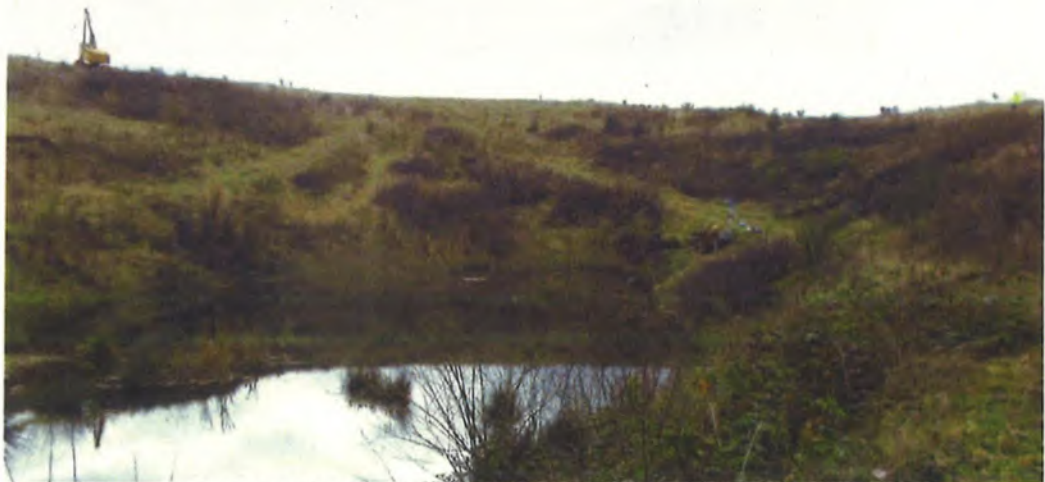
Reservoir pool and adjacent landfill slope – looking south

[REDACTED] Completion of restoration soil cover has been recommended in previous inspections, and this is affirmed in this Report.

- (1) Re-grade the upstream slopes of the embankment around the shores of the reservoir pool to the specified maximum slope of 1 Vertical in 4 Horizontal.
- (2) Complete restoration soils over the upstream slopes of the embankment around the shores of the reservoir area to a minimum 300mm depth and include a growth medium to establish suitable grass cover.
- (3) Re-profile the erosion channels on the left shore of the reservoir pool and extend the restoration soil layer specified to the areas draining from the site to the channels and the reservoir shores, in conjunction with re-profiling of the steep parts of the upstream face.
- (4) Complete the restoration soils over the unrestored areas of the site to a minimum 300mm depth and include a growth medium to establish suitable grass cover _____

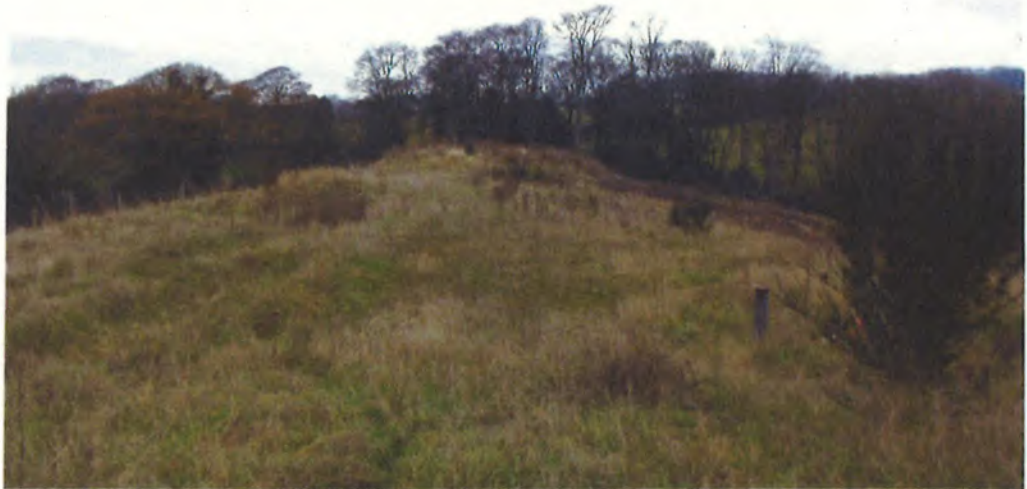
Top of embankment looking towards Right (north-west) end

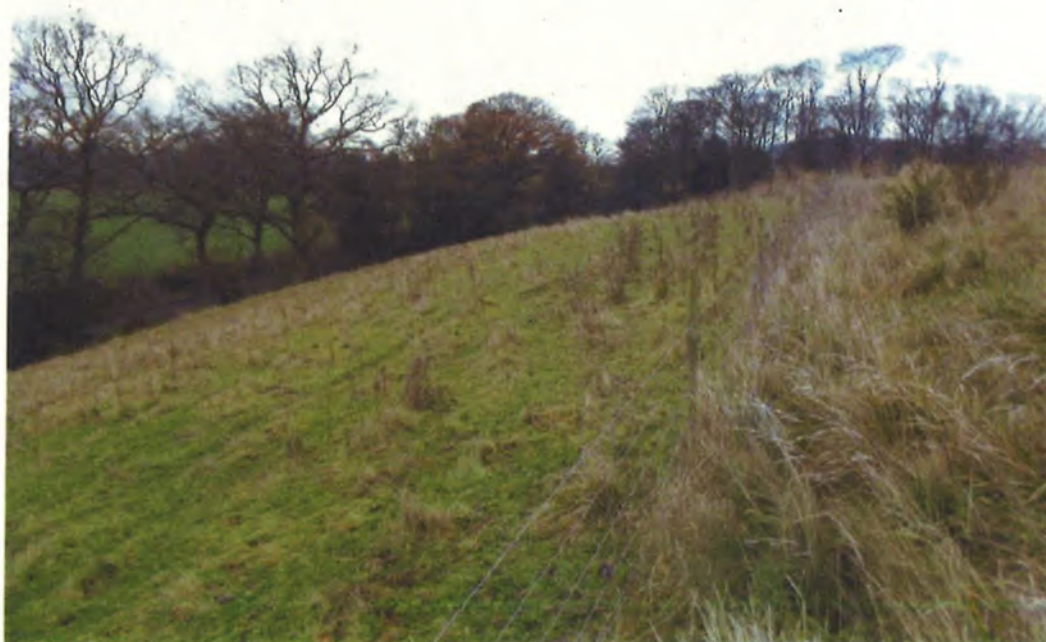
The lower parts of the downstream face on the west and south faces have been restored and are grazed by sheep, that maintains a good grass sward protecting the surface and facilitating visual surveillance (Photograph below).

Restored part of downstream face of embankment

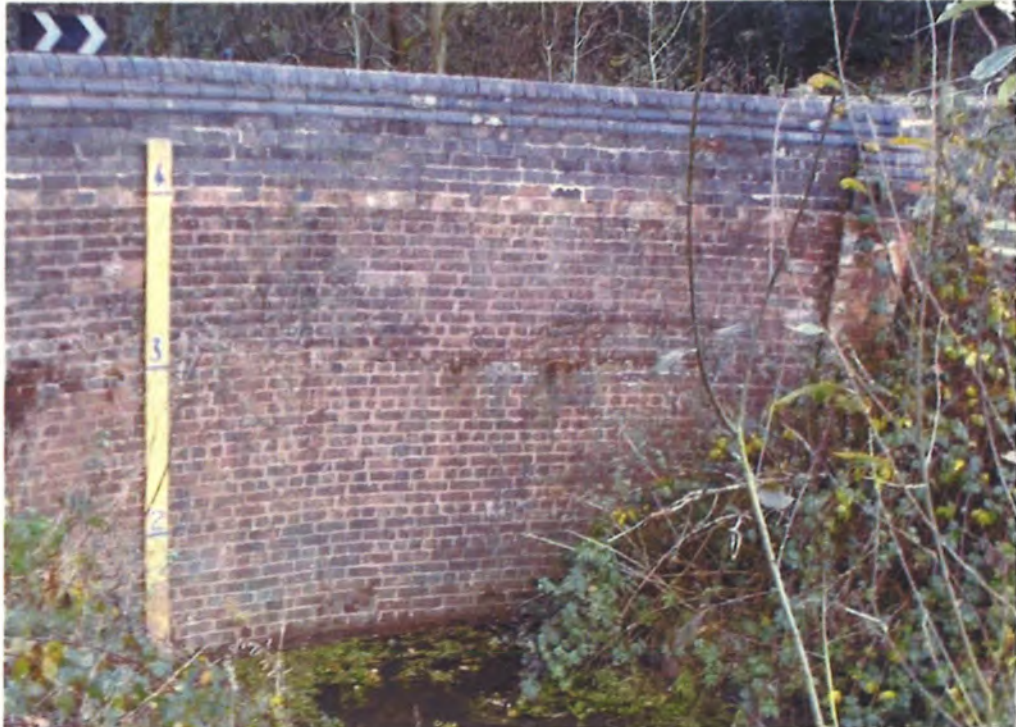
A gauge board is installed on the headwall of the culvert under Alvechurch Highway with the base at the invert of the culvert. Water levels have been recorded based on this as a local zero datum level.

Gauge board on bridge under Alvechurch Highway
