MARLBROOK QUARRY RESERVOIR

**REPORT ON AN INSPECTION UNDER SECTION 8 OF THE
RESERVOIRS ACT 1975**

Final

October 2019

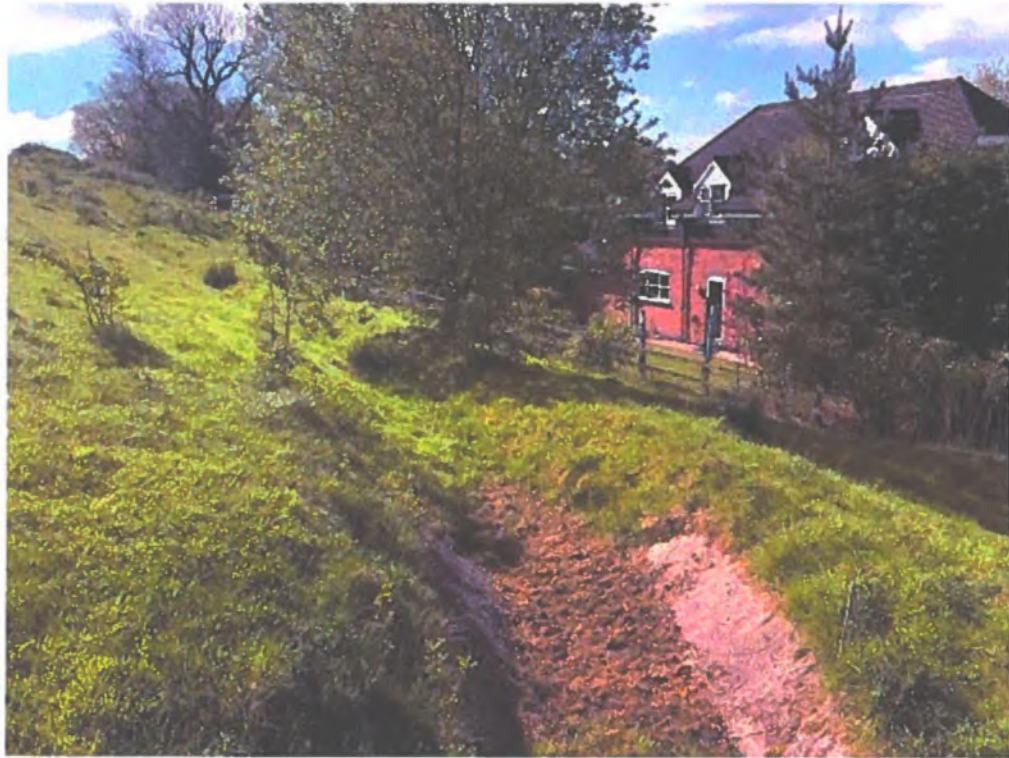
Property downstream

Immediately downstream of the dam are a number of residential properties associated with Lower Marlbrook and Upper Catshill in the natural valley of the stream before it passes under the M42.

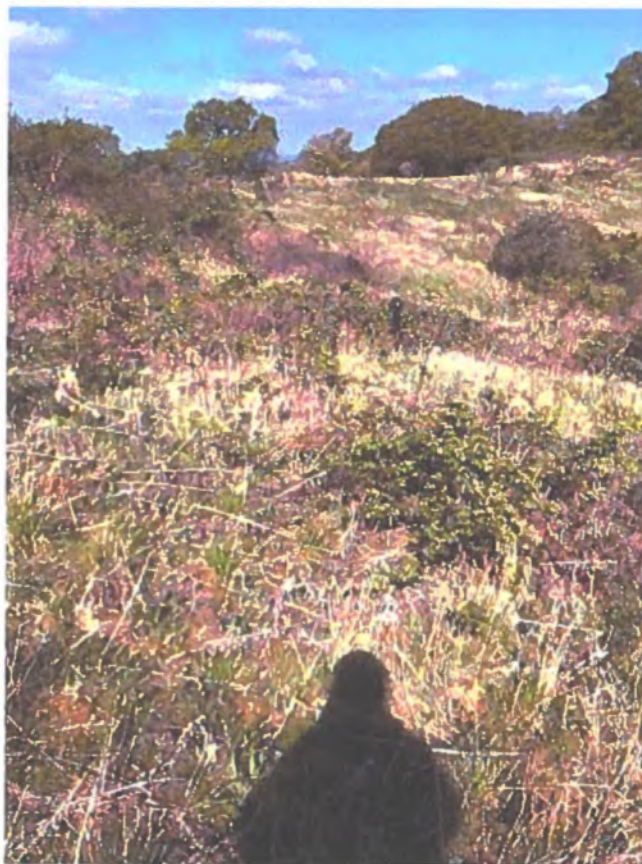
Basin/crest at right side

The crest is a little uneven in places but has a satisfactory line and level and good grass cover. [REDACTED]
