## **LIBERTY CONSTRUCTION LTD**

**Name of Reservoir: *Marlbrook Quarry Reservoir***

Report under Section 8

**Date: January 2015**

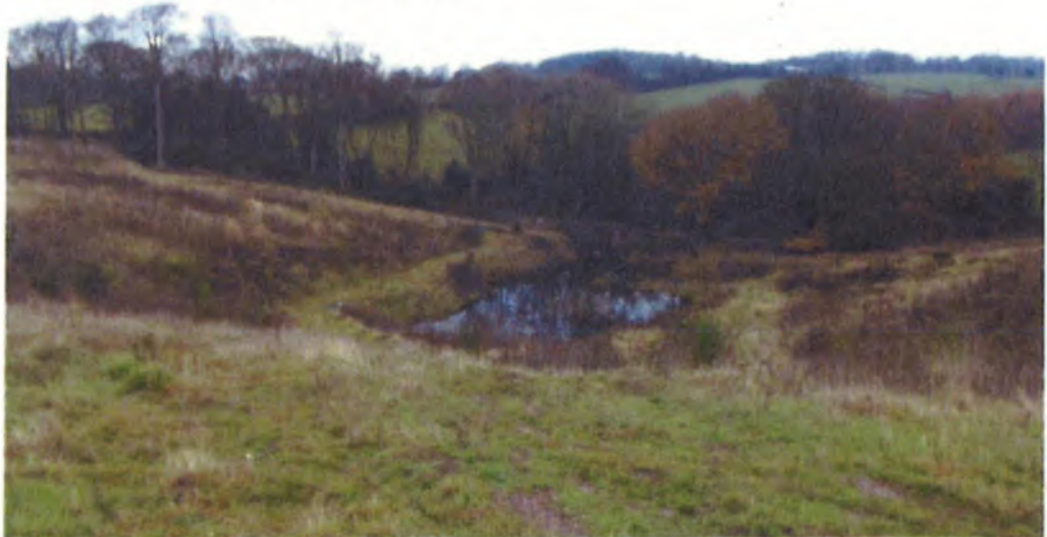
Reservoir pool area – looking north

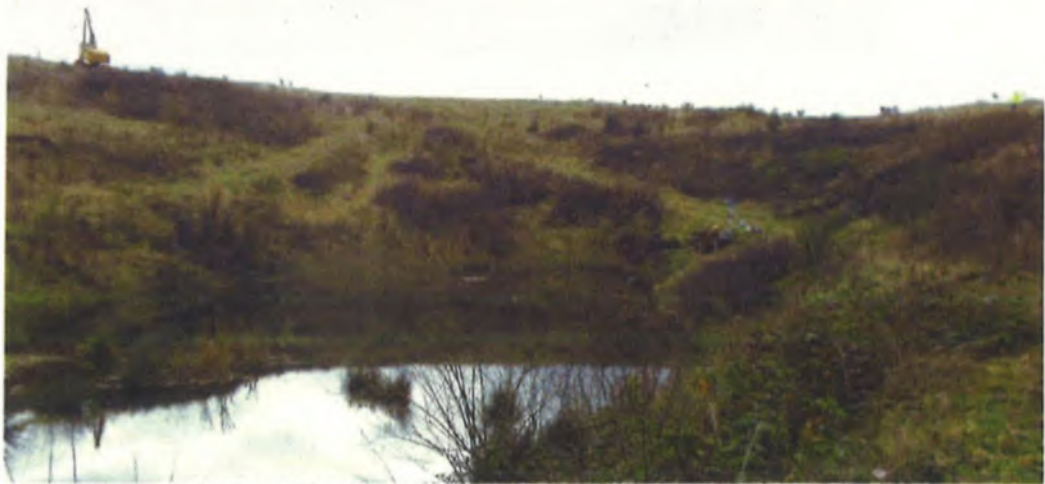
As stated in the 2013 inspection report, this is not considered necessary for this reservoir which is for flood balancing and is normally empty, and lies in a situation well sheltered from wind.

Reservoir pool and adjacent landfill slope – looking south

- (1) Re-grade the upstream slopes of the embankment around the shores of the reservoir pool to the specified maximum slope of 1 Vertical in 4 Horizontal.
- (2) Complete restoration soils over the upstream slopes of the embankment around the shores of the reservoir area to a minimum 300mm depth and include a growth medium to establish suitable grass cover.
- (3) Re-profile the erosion channels on the left shore of the reservoir pool and extend the restoration soil layer specified to the areas draining from the site to the channels and the reservoir shores, in conjunction with re-profiling of the steep parts of the upstream face.
- (4) Complete the restoration soils over the unrestored areas of the site to a minimum 300mm depth and include a growth medium to establish suitable grass cover [REDACTED]

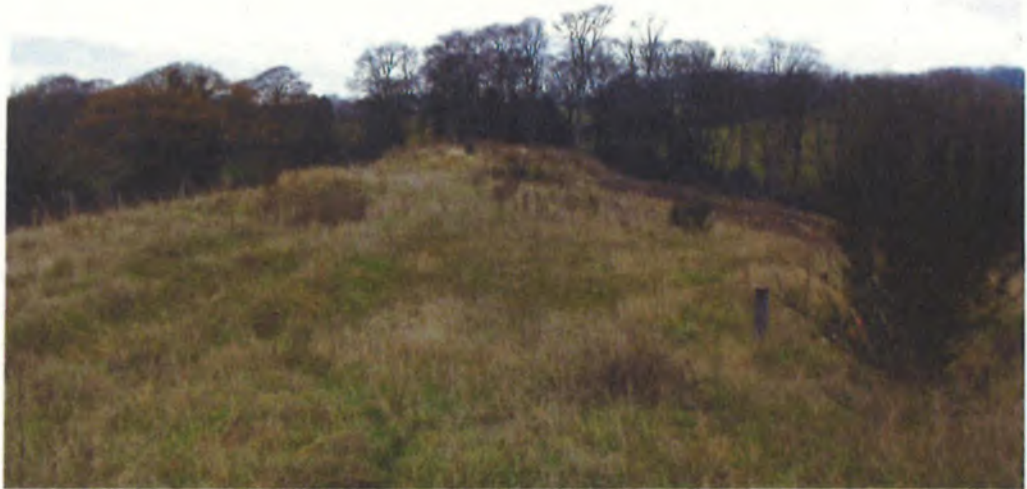
[REDACTED] Completion of restoration soil cover has been recommended in previous inspections, and this is affirmed in this Report.

Top of embankment looking towards Right (north-west) end

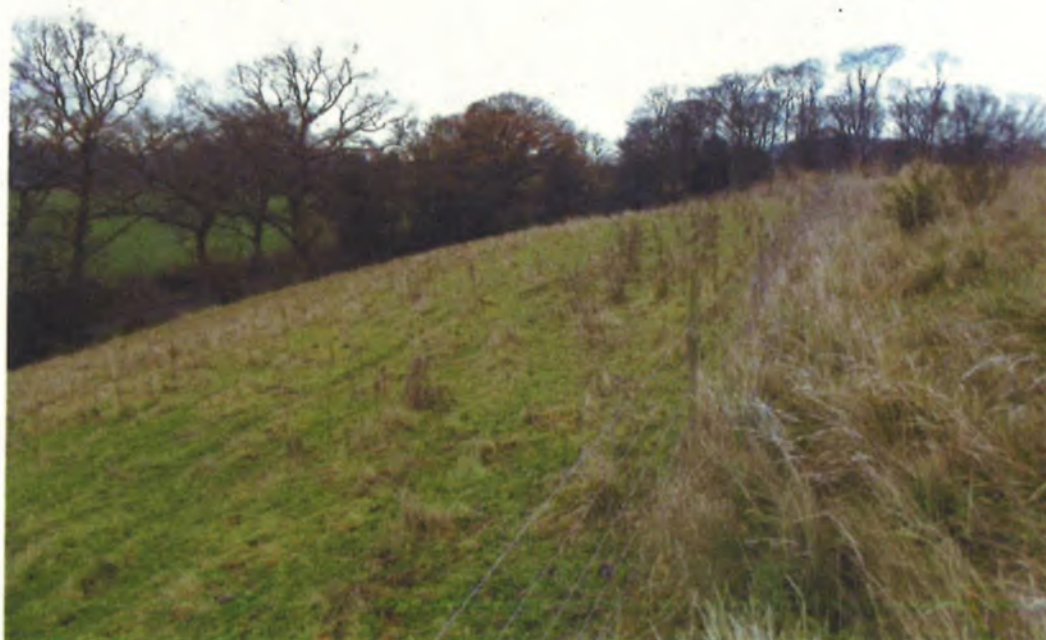
The lower parts of the downstream face on the west and south faces have been restored and are grazed by sheep, that maintains a good grass sward protecting the surface and facilitating visual surveillance (Photograph below).

Restored part of downstream face of embankment

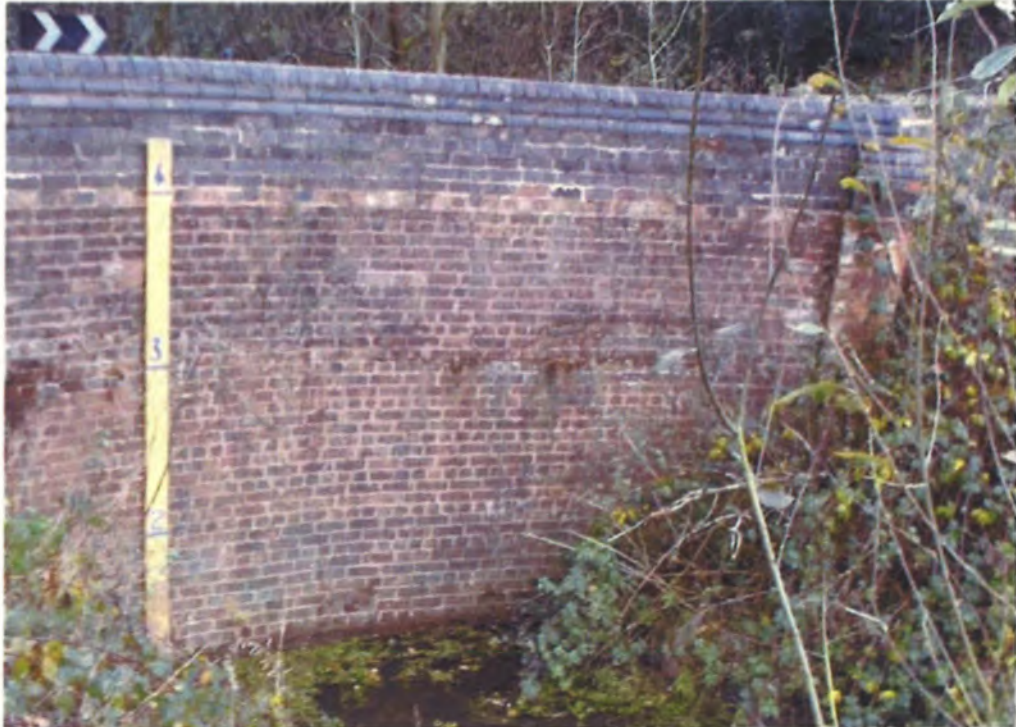
A gauge board is installed on the headwall of the culvert under Alvechurch Highway with the base at the invert of the culvert. Water levels have been recorded based on this as a local zero datum level.

Gauge board on bridge under Alvechurch Highway
