Final Report Marlbrook Landfill Site

Marlbrook Landfill Site
Marlbrook Lane
Bromsgrove
B60 1HP

Client	Worcester Regulatory Services
Client Reference	Mark Cox
Project	Marlbrook Landfill Site
Document Title	Final Report
Document Reference	EXEA/Marlbrook/2016

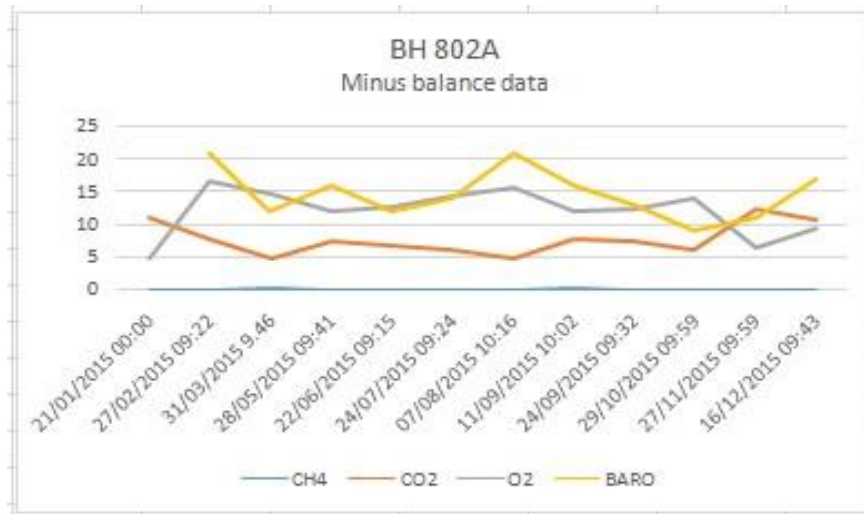
Borehole 802A without balance data

Borehole reference 802a		
Condition	Y/N	Comment
Borehole inaccessible or headworks missing	Y	BH visited on all occasions
Air entry into borehole	Y	
Barometric pumping	Y	
Enrichment of methane	N

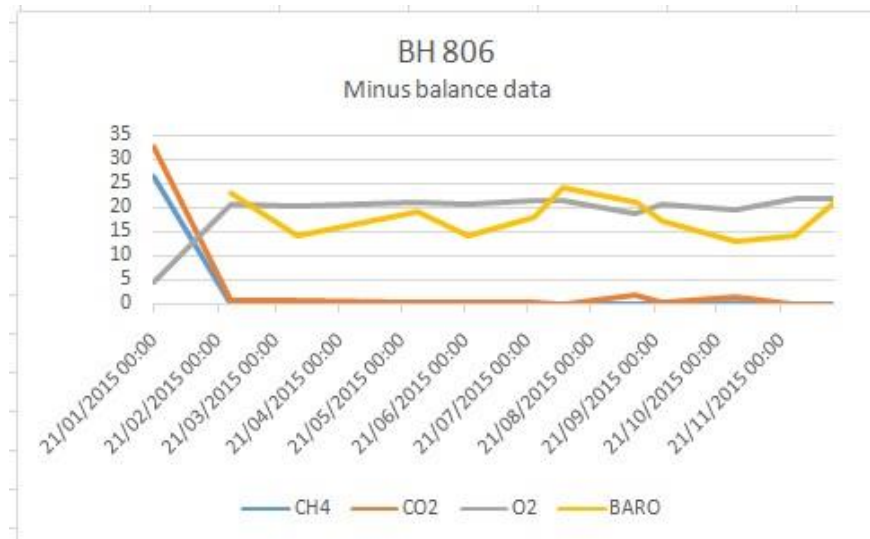
Borehole 806 without balance data

Borehole reference 806		
Condition	Y/N	Comment
Borehole inaccessible or headworks missing	Y	Borehole visited on all occasions
Air entry into borehole	Y	
Barometric pumping	N	
Enrichment of methane	N

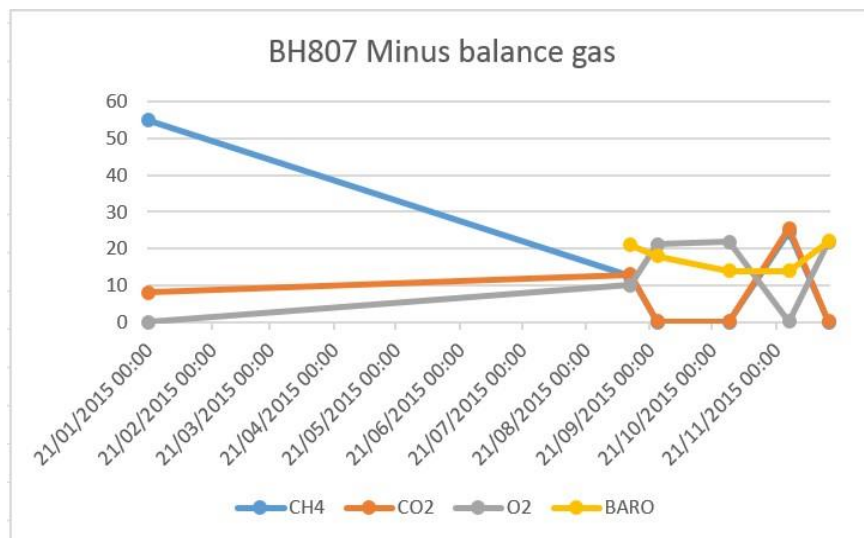
Borehole 807 without balance data

Borehole reference 807		
Condition	Y/N	Comment
Borehole inaccessible or headworks missing	Y	Inaccessible on 6 occasions
Air entry into borehole		Insufficient data
Barometric pumping		Insufficient data
Enrichment of methane		Insufficient data

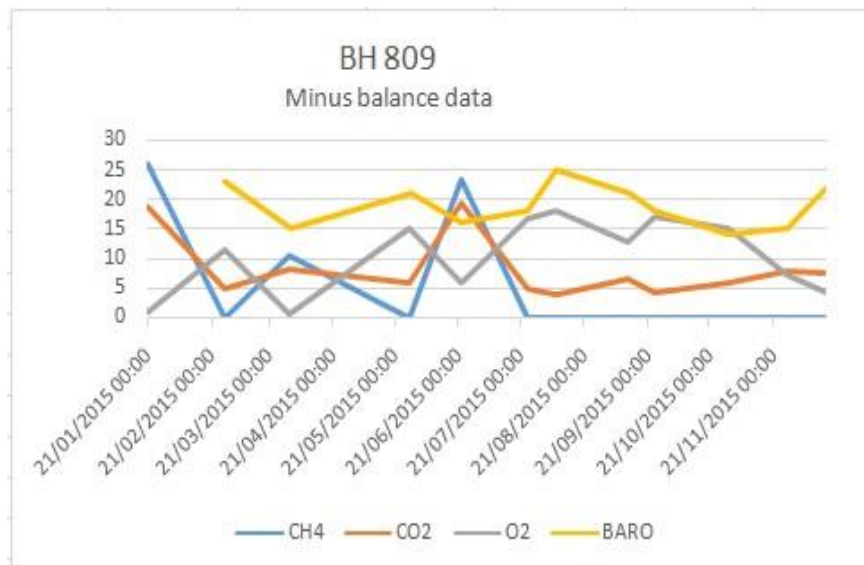
Borehole 809 without balance

Borehole reference 809		
Condition	Y/N	Comment
Borehole inaccessible or headworks missing	Y	BH visited on all occasions
Air entry into borehole	Y	
Barometric pumping	Y	
Enrichment of methane	N

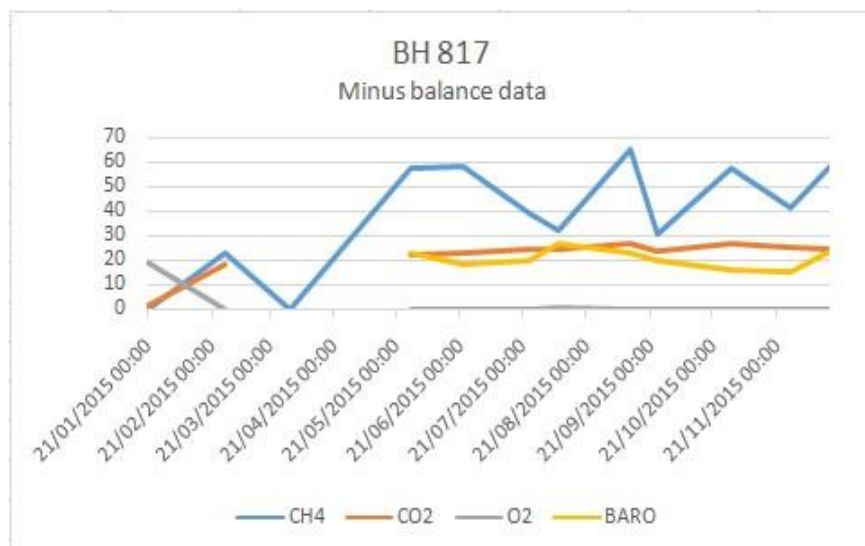
Borehole 817 without balance data

Borehole reference 817		
Condition	Y/N	Comment
Borehole inaccessible or headworks missing	Y	Inaccessible on one occasion.
Air entry into borehole	N	Severely weathered with enriched balance
Barometric pumping	Y	
Enrichment of methane	N

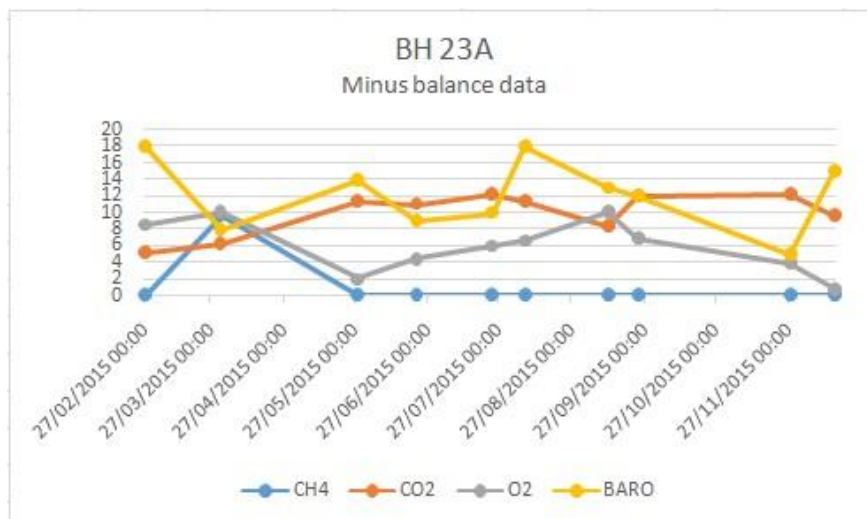
Borehole 823A without balance data

Borehole reference 823A		
Condition	Y/N	Comment

Borehole inaccessible or headworks missing	Y	Inaccessible on a couple of occasions
Air entry into borehole	Y	Air present – balance at atmospheric
Barometric pumping	Y	Not as obvious
Enrichment of methane	N	Methane only present on a single occasion

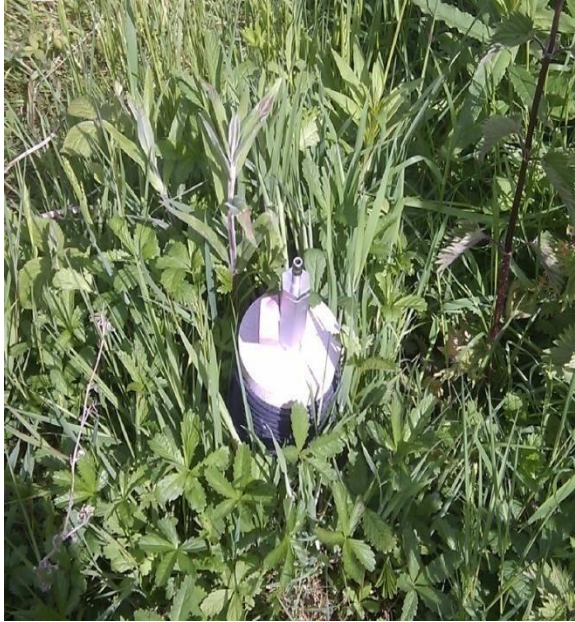
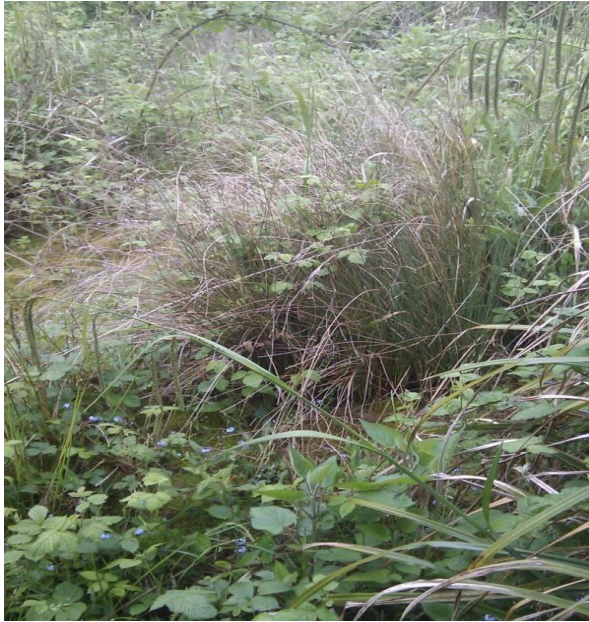
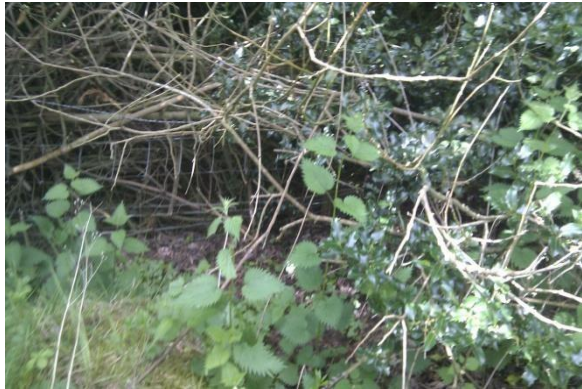
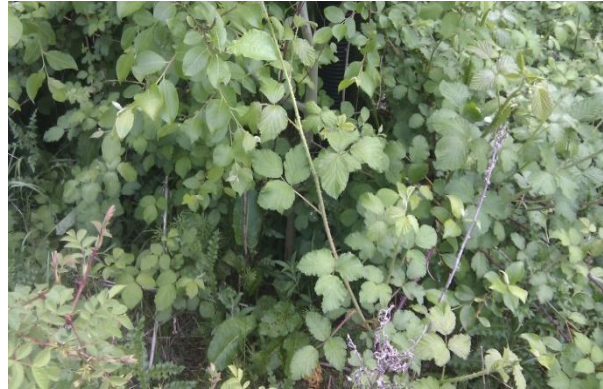
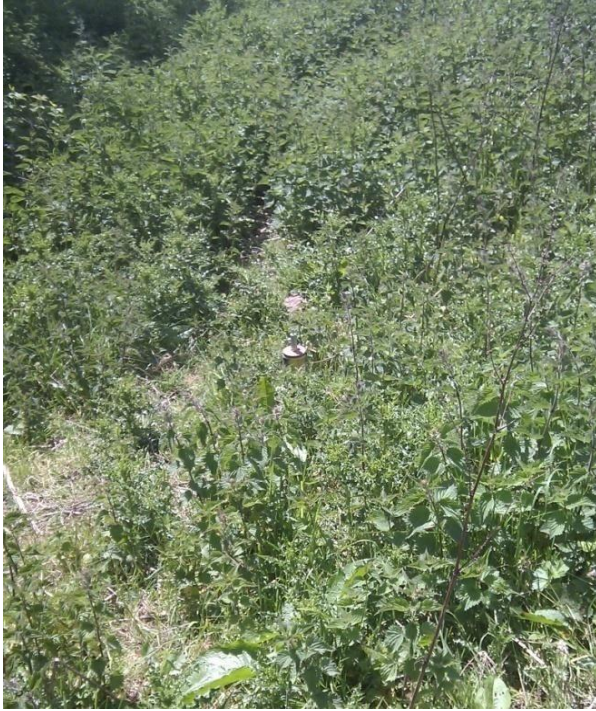
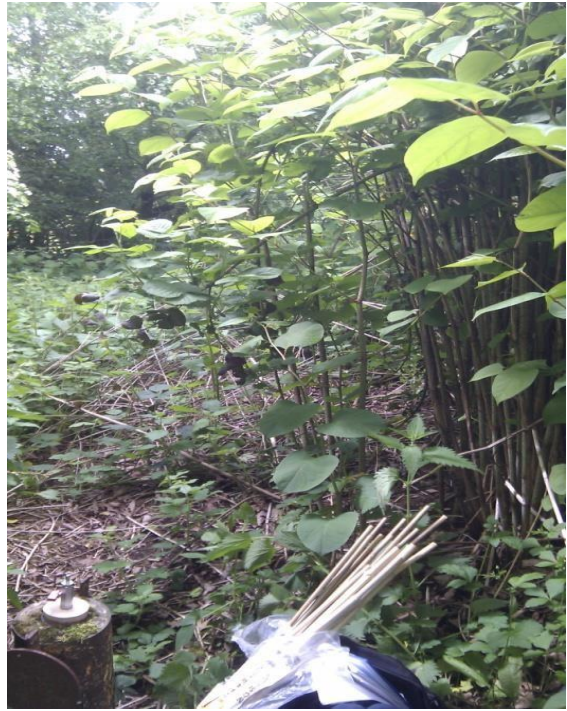
Appendix 3 – photographs of site conditions

- There is unreliable access to many of the boreholes as the site is overgrown with brambles and access to boreholes is not regularly maintained, this raises a safety issue for “AECOM” and Exea Associates Limited when approaching and finding hidden boreholes. This fact has been made known to all parties involved with the site.

- A number of boreholes were without monitoring infrastructure for several occasions, this means full assessment cannot be made.
- Borehole headworks in some instances are not secure and there has been deliberate damage caused during the contract period.

- All boreholes need to be clearly marked and access made easy. This recommendation falls outside of the scope of the works commissioned to Exea Associates Limited but is highly important as it will enable future monitoring works to be carried out in a safe manner.
