# Final Report

## Marlbrook Landfill Site

Bromsgrove

<b>Client</b>	<b>Worcester Regulatory Services</b>
<b>Client Reference</b>	<b>Mark Cox</b>
<b>Project</b>	<b>Marlbrook Landfill Site</b>
<b>Document Title</b>	<b>Final Report</b>
<b>Document Reference</b>	<b>EXEA/Marlbrook/2016</b>

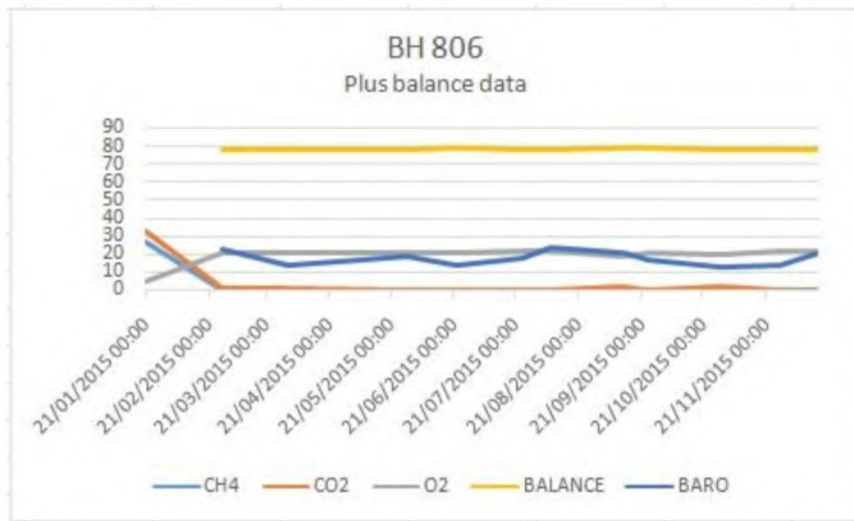
**Borehole 806 without balance data**

Borehole reference 806		
Condition	Y/N	Comment
Borehole inaccessible or headworks missing	Y	Borehole visited on all occasions
Air entry into borehole	Y	
Barometric pumping	N	
Enrichment of methane	N

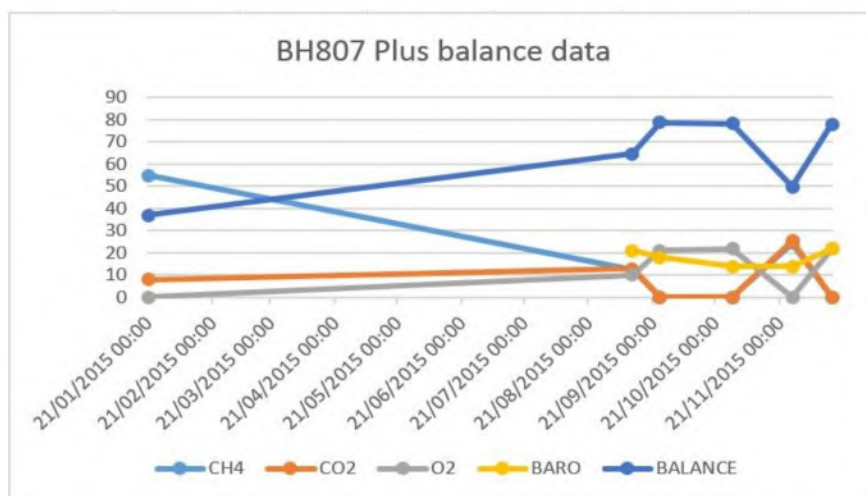
**Borehole 807 without balance data**

<b>Borehole reference 807</b>		
<b>Condition</b>	<b>Y/N</b>	<b>Comment</b>
Borehole inaccessible or headworks missing	Y	Inaccessible on 6 occasions
Air entry into borehole		Insufficient data
Barometric pumping		Insufficient data
Enrichment of methane		Insufficient data

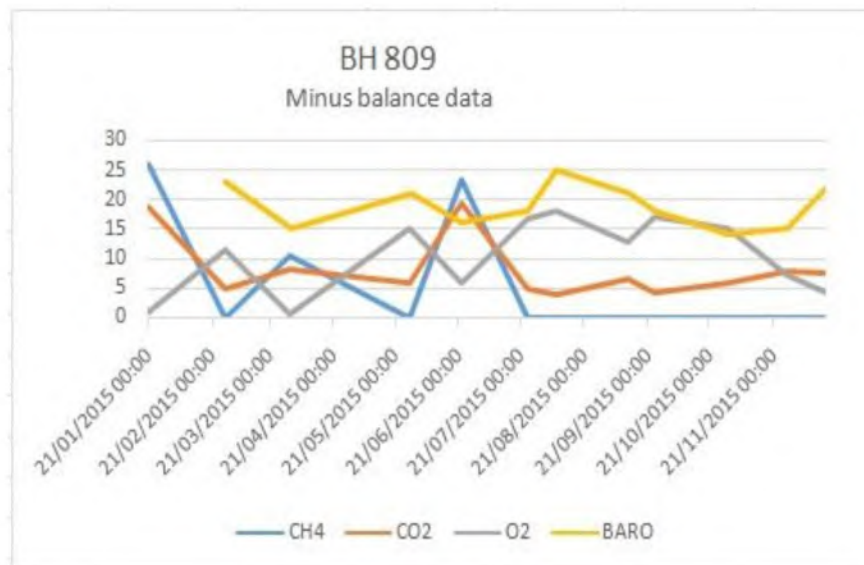
**Borehole 809 without balance**

Borehole reference 809		
Condition	Y/N	Comment
Borehole inaccessible or headworks missing	Y	BH visited on all occasions
Air entry into borehole	Y	
Barometric pumping	Y	
Enrichment of methane	N

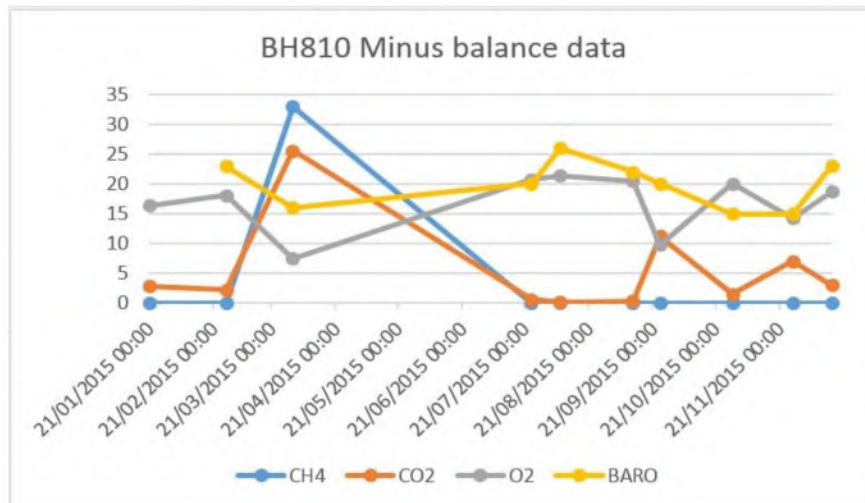
**Borehole 810 without balance data**

<b>Borehole reference 810</b>		
<b>Condition</b>	<b>Y/N</b>	<b>Comment</b>
Borehole inaccessible or headworks missing	Y	BH inaccessible on two occasions
Air entry into borehole	Y	
Barometric pumping	Y	
Enrichment of methane	N

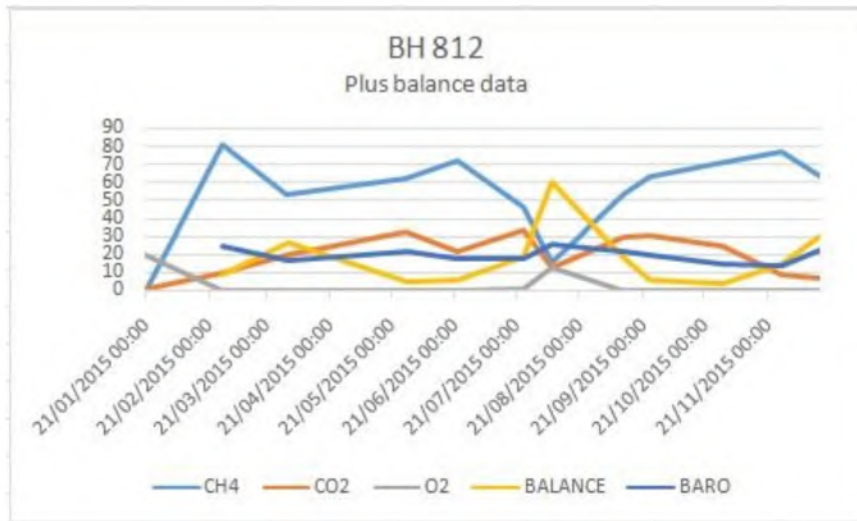
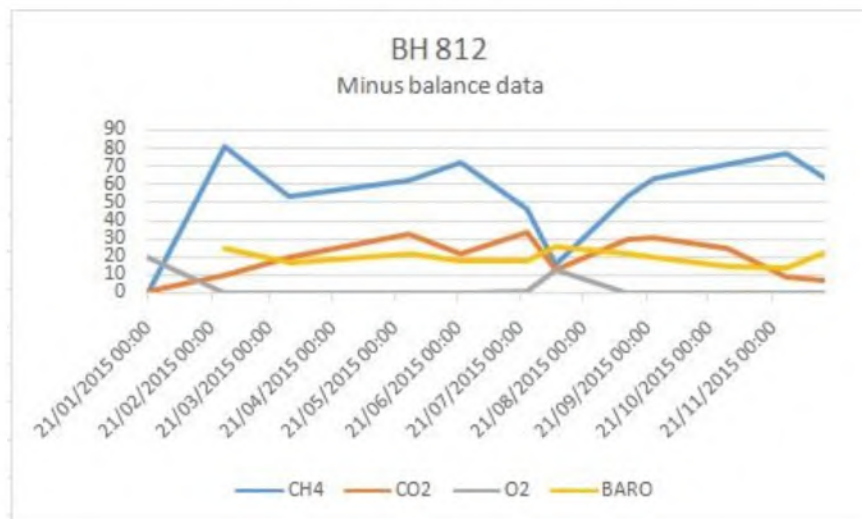
**Borehole 812 without balance data**

<b>Borehole reference 812</b>		
<b>Condition</b>	<b>Y/N</b>	<b>Comment</b>
Borehole inaccessible or headworks missing	Y	BH visited on all occasions.
Air entry into borehole	Y	
Barometric pumping	Y	
Enrichment of methane	Y

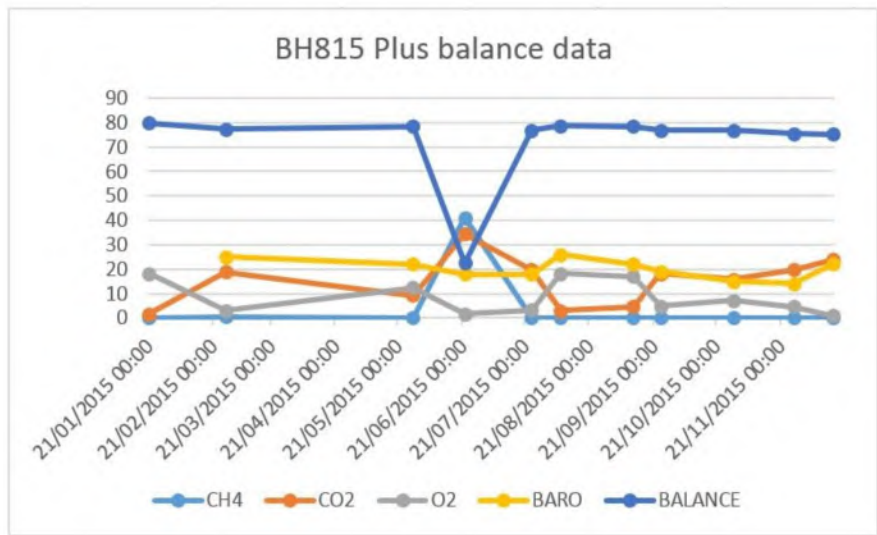
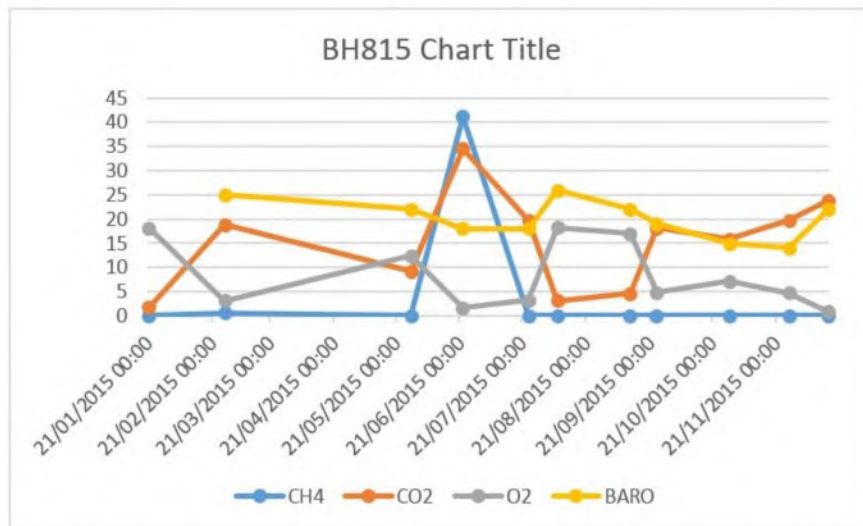
**Borehole 815 without balance data**

<b>Borehole reference 815</b>		
<b>Condition</b>	<b>Y/N</b>	<b>Comment</b>
Borehole inaccessible or headworks missing	Y	Inaccessible on one occasion.
Air entry into borehole	Y	Enriched Nitrogen
Barometric pumping	Y	
Enrichment of methane	N

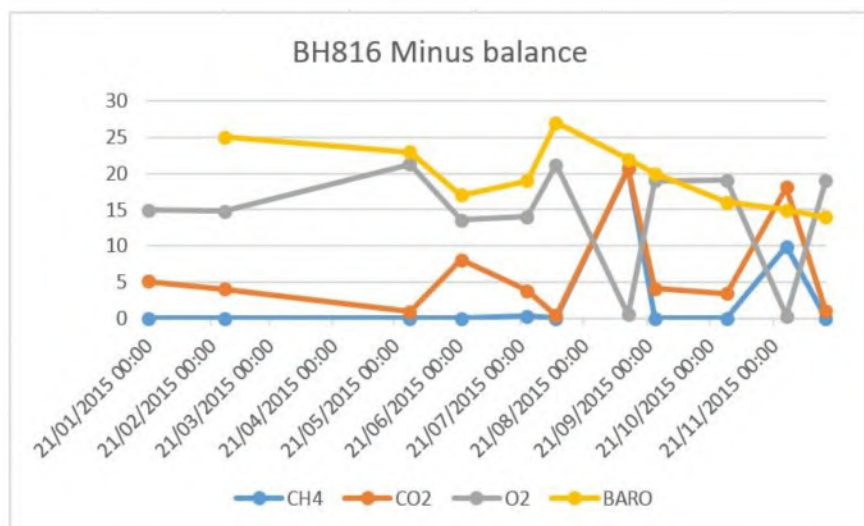
**Borehole 816 without balance data**

Borehole reference 816		
Condition	Y/N	Comment
Borehole inaccessible or headworks missing	Y	Inaccessible on one occasion.
Air entry into borehole	Y	
Barometric pumping	Y	For CO2 only
Enrichment of methane	Y

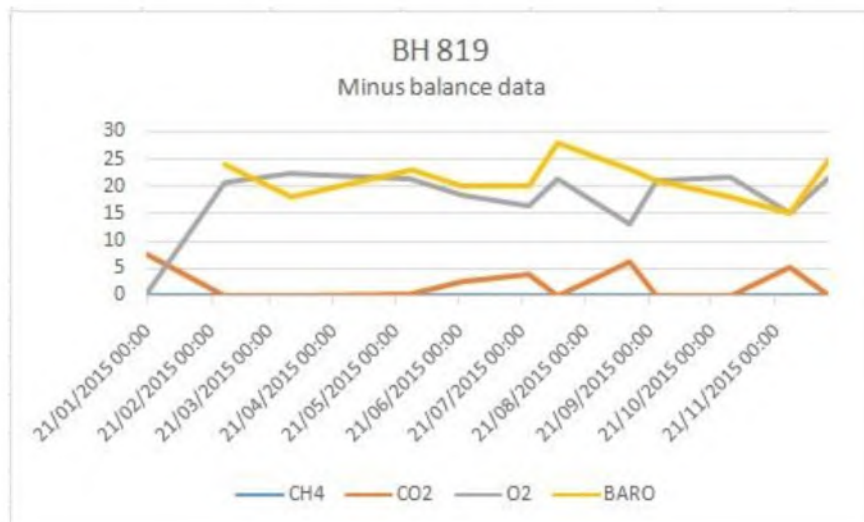
**Borehole 819 without balance data**

<b>Borehole reference 819</b>		
<b>Condition</b>	<b>Y/N</b>	<b>Comment</b>
Borehole inaccessible or headworks missing	N	Accessible on all occasions
Air entry into borehole	Y	
Barometric pumping	N	Not obvious
Enrichment of methane	N

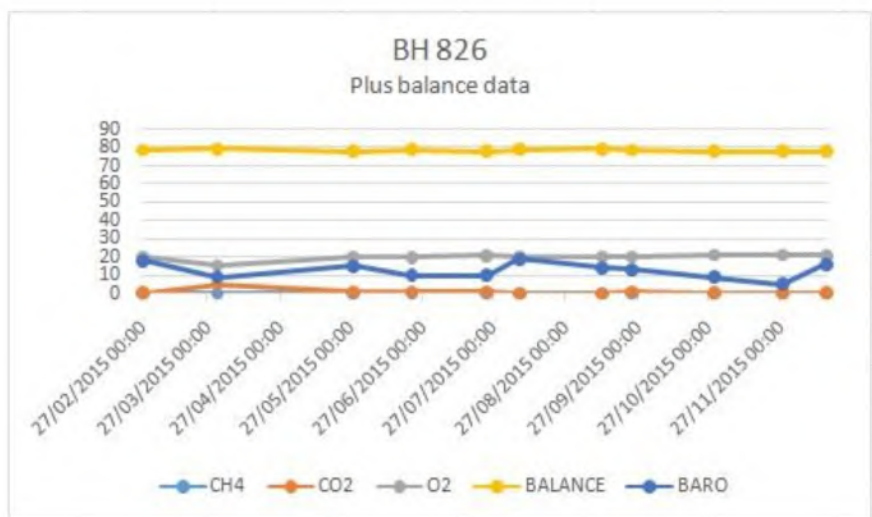
**Borehole 826 without balance data**

Borehole reference 826		
Condition	Y/N	Comment
Borehole inaccessible or headworks missing	Y	Inaccessible on a single occasion
