Name of Reservoir: *Marlbrook Quarry Reservoir*

Report under Section 8

Robert J Mann, BA, MICE, MCIWEM, AR Panel Engineer

Date: January 2015

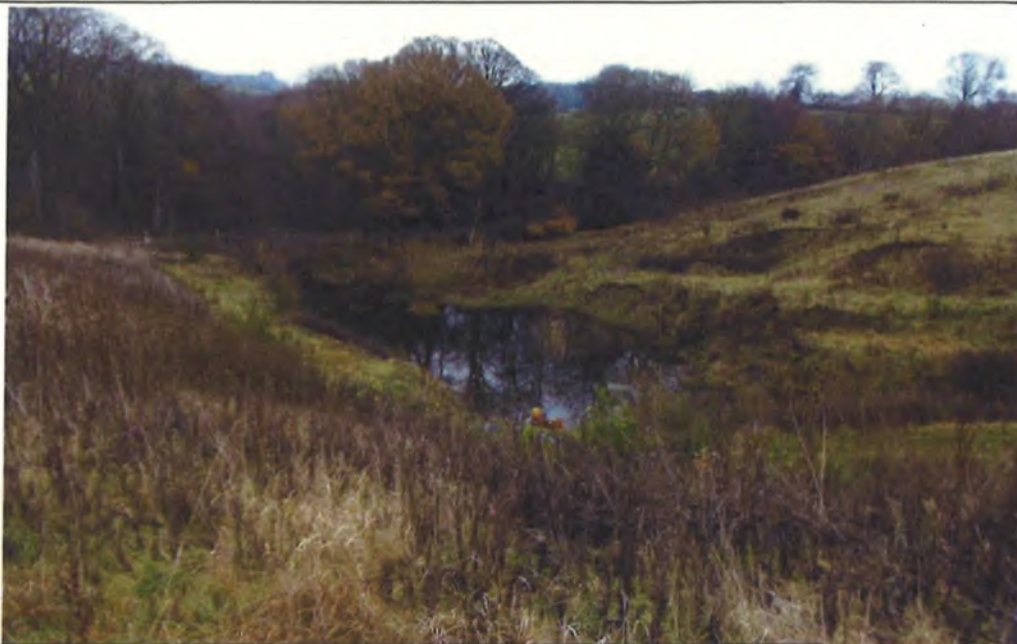
Stability under and following flood events is also a consideration. Floods will cause temporary impoundment [REDACTED]. Flood assessment and routing carried out [REDACTED] has established that the flood rise would be significant for extreme floods approaching the PMF design flood. [REDACTED]

[REDACTED] A maximum slope of 1 Vertical in 4 Horizontal has been directed in original designs for the embankment prepared by Aecom, and is referred to and affirmed in Peter Kelham's Inspection Report. Therefore a recommendation in the interests of safety is made to re-grade the upstream slopes forming the shores of the reservoir pool to the specified maximum slope of 1 Vertical in 4 Horizontal. [REDACTED]

A direction was made in the Inspection Report dated 31 March 2013 as follows: *Until the works covering the site are completed I recommend that the monitoring of the water levels in the piezometers should be undertaken at two monthly intervals to monitor the leachate levels*

Additionally a data logger shall be installed in piezometer L4A to record leachate levels daily.
