## **LIBERTY CONSTRUCTION LTD**

**Name of Reservoir: *Marlbrook Quarry Reservoir***

Report under Section 8

**Date: January 2015**

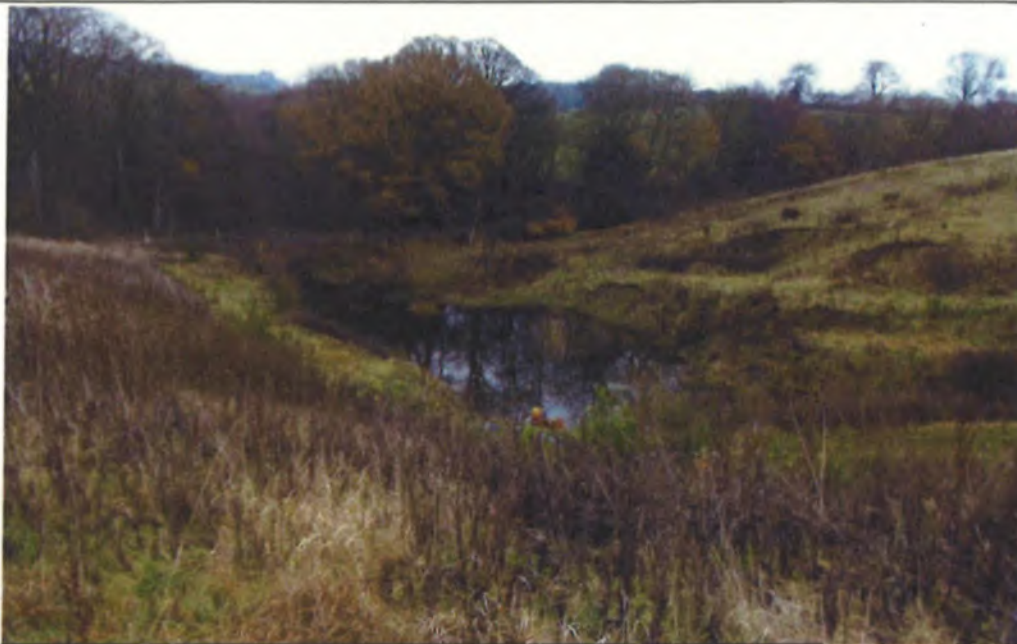
Stability under and following flood events is also a consideration. Floods will cause temporary impoundment [REDACTED]. Flood assessment and routing carried out [REDACTED] has established that the flood rise would be significant for extreme floods approaching the PMF design flood. [REDACTED]

[REDACTED] A maximum slope of 1 Vertical in 4 Horizontal has been directed in original designs for the embankment prepared by Aecom, and is referred to and affirmed in Peter Kelham's Inspection Report. Therefore a recommendation in the interests of safety is made to re-grade the upstream slopes forming the shores of the reservoir pool to the specified maximum slope of 1 Vertical in 4 Horizontal. [REDACTED]
